RE: Site Technical Visit, Moab Salt, Cane Creek Mine, M/019/005, Grand County, Utah

Date of Inspection: December 12, 2002  
Time of Inspection: 9:20 a.m. to 2:45 p.m.  
Conditions: Mostly sunny, 40's  
Participants: Steve Viert and Erik Mohr, Cedar Creek Associates; Rick Klein, Moab Salt; Paul Baker, DOGM

The operator is considering how to best reclaim the evaporation ponds. The purpose was to meet with the operator's consultants and discuss different revegetation options.

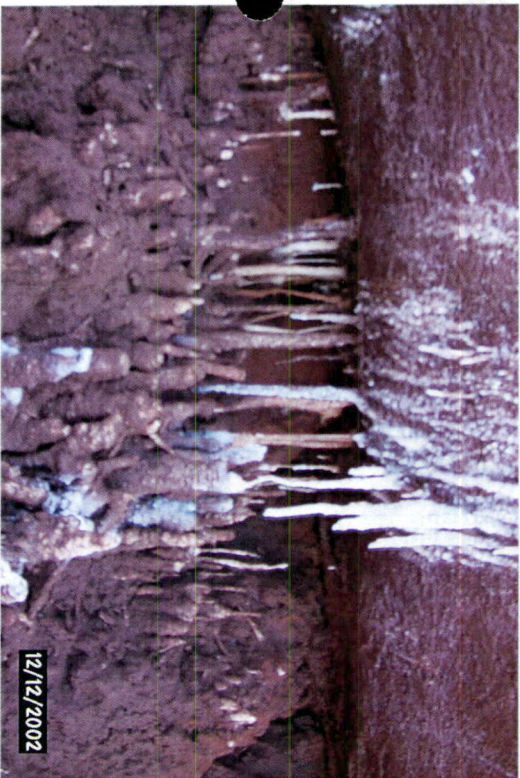
1. Many of the rock outcrops downhill from the ponds have salt accumulations that look much like stalactites and stalagmites (Photo 1). There is also water running in some of the drainages, and this indicates that the liners in the ponds leak and that the soils are probably contaminated with salt. Although we do not know the precise extent of salt contamination, we assume it is widespread.

Photo 1. Stalactite- and stalagmite-like formations in one of the drainages below the evaporation ponds.

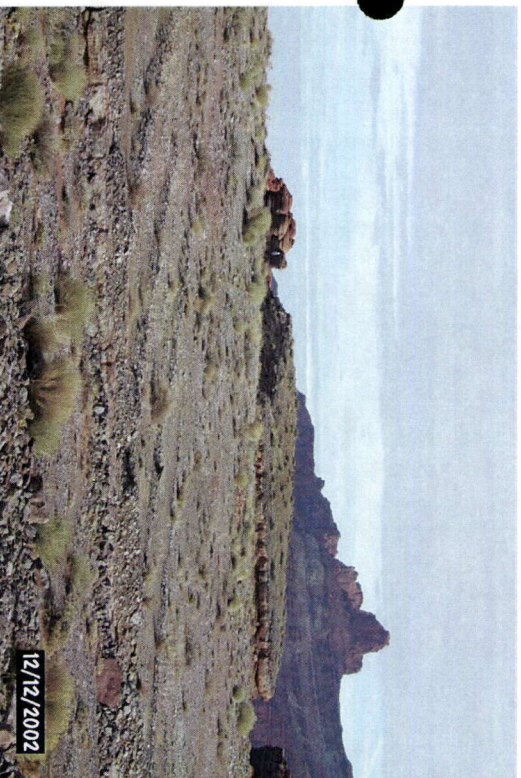
2. There is one area from which soil was borrowed to make the dams, and little soil remains over the bedrock (Photo 2). Mr. Viert and Mr. Mohr were taking vegetation cover data in this area to see the effects on the vegetation of borrowing this soil.

Photo 2. Area from which material was taken to build the dams.

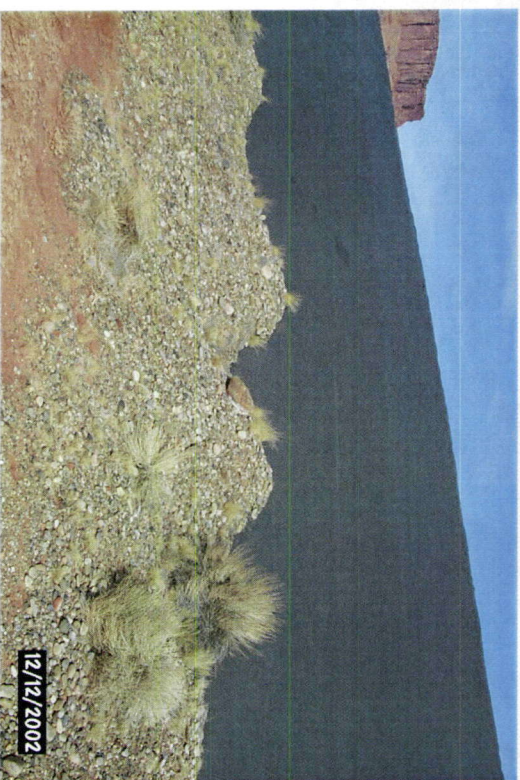
3. There are several places where soil has been placed at the edges of the liners to hold the liners in place, and vegetation, mostly native, has become established in most of these areas (Photos 3 and 4). The consultants were taking vegetation cover data in these areas with the idea of relating it to a reclamation scenario where the liners are not removed. I anticipate the operator will submit the consultants' quantitative data, but my general impression was that there was a surprising amount of vegetation. The amount of cover may rival that in undisturbed areas.

Photo 3. Soil piles on the edge of the liner. Note the amount of vegetation despite the small amount of soil. See also Photo 4.

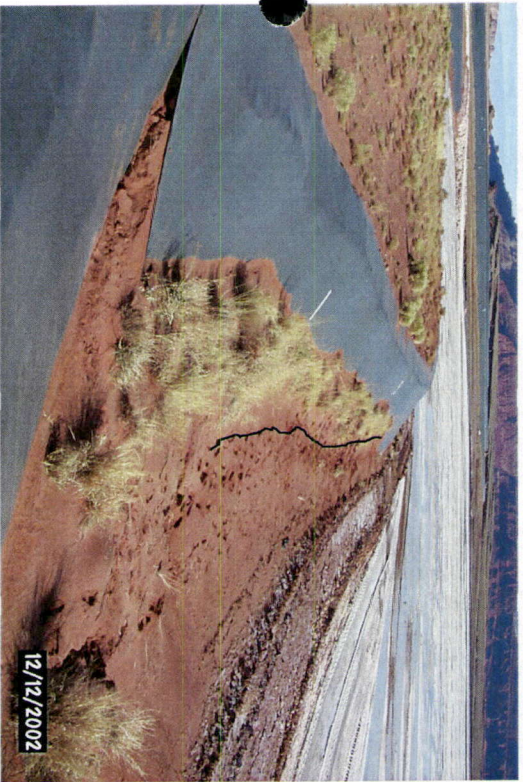
4. There was one area where soil—basically sand—had blown on to the edge of the pond, and vegetation has become established above the water line in this area (Photo 5).

**Photo 5.** Area at the edge of one of the ponds where soil has blown in. The high water mark is marked near the center of the photo with a black line.

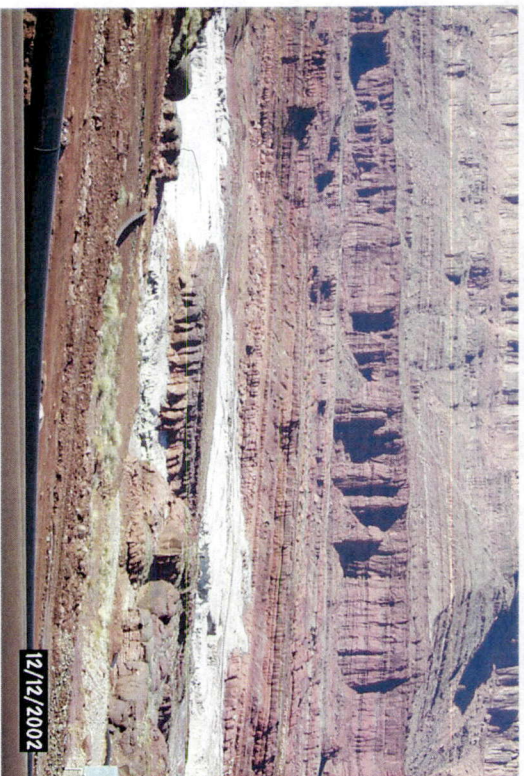
6. The operator showed me the salt tailings area (Photo 6). Much of the salt that was stored in this area has been removed, and it should all be gone within a few years.

**Photo 6.** The salt tailings area.
